Environmental Data Analysis Report

Damp And Mould Causation & Property Condition
Assessment

Report Reference: VER-DM-[Case Ref]

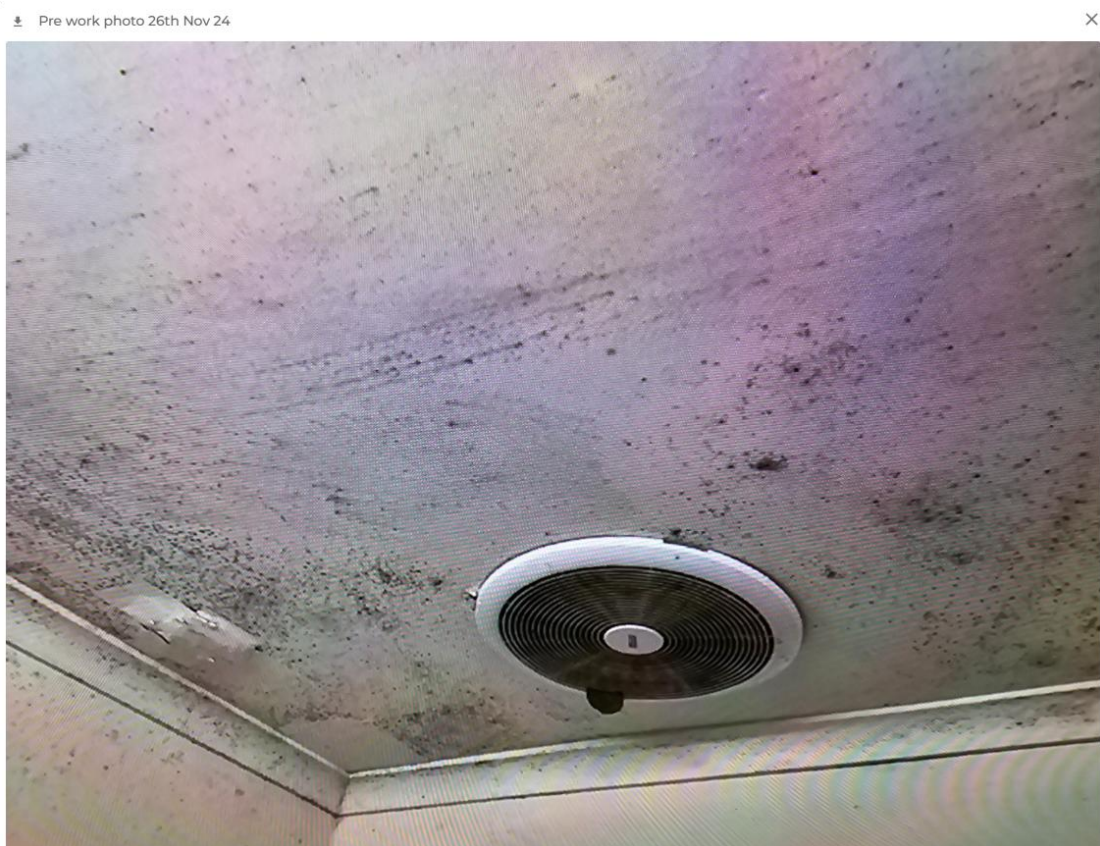
Figure 1 – Bathroom Ceiling (Pre-Works Condition)

Date: 26 November 2024

- Visible mould growth across ceiling surface
- Pattern consistent with condensation accumulation
- Extractor fan present within area

The photographic evidence supports the conclusion that the condition observed is consistent with **condensation-related mould growth rather than structural defect**, and forms part of the overall evidential record alongside environmental data, audit logs, and system-generated activity.

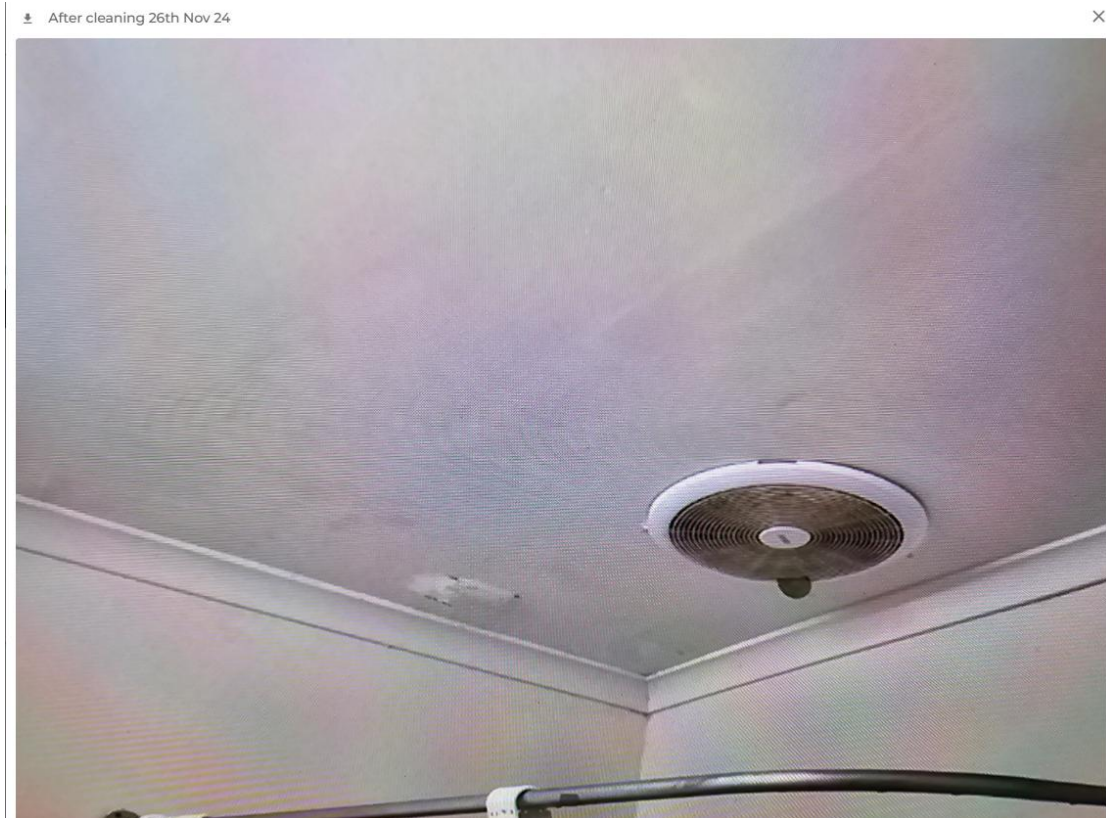
Figure 2 – Bathroom Ceiling (Post-Cleaning Condition)

Date: 26 November 2024

- Surface cleaned and mould removed
- No visible indication of persistent saturation
- No evidence of structural water ingress

- Mould presence is **surface-level and responsive to cleaning**
- Growth pattern is consistent with **humidity-related condensation**
- No visual indicators of:
 - Penetrating damp
 - Structural defect
 - Continuous water ingress
